# *Important Cultural Property / Erosion and Sediment Control Work for the Momijidani River Park*

*The first civil engineering  
facility which was  
constructed after WWII, to  
be designated as an  
"Important Cultural  
Property" in Japan*

## *Erosion and Sediment Control Project in Harmony with the Historical Scenery of Itsukushima*

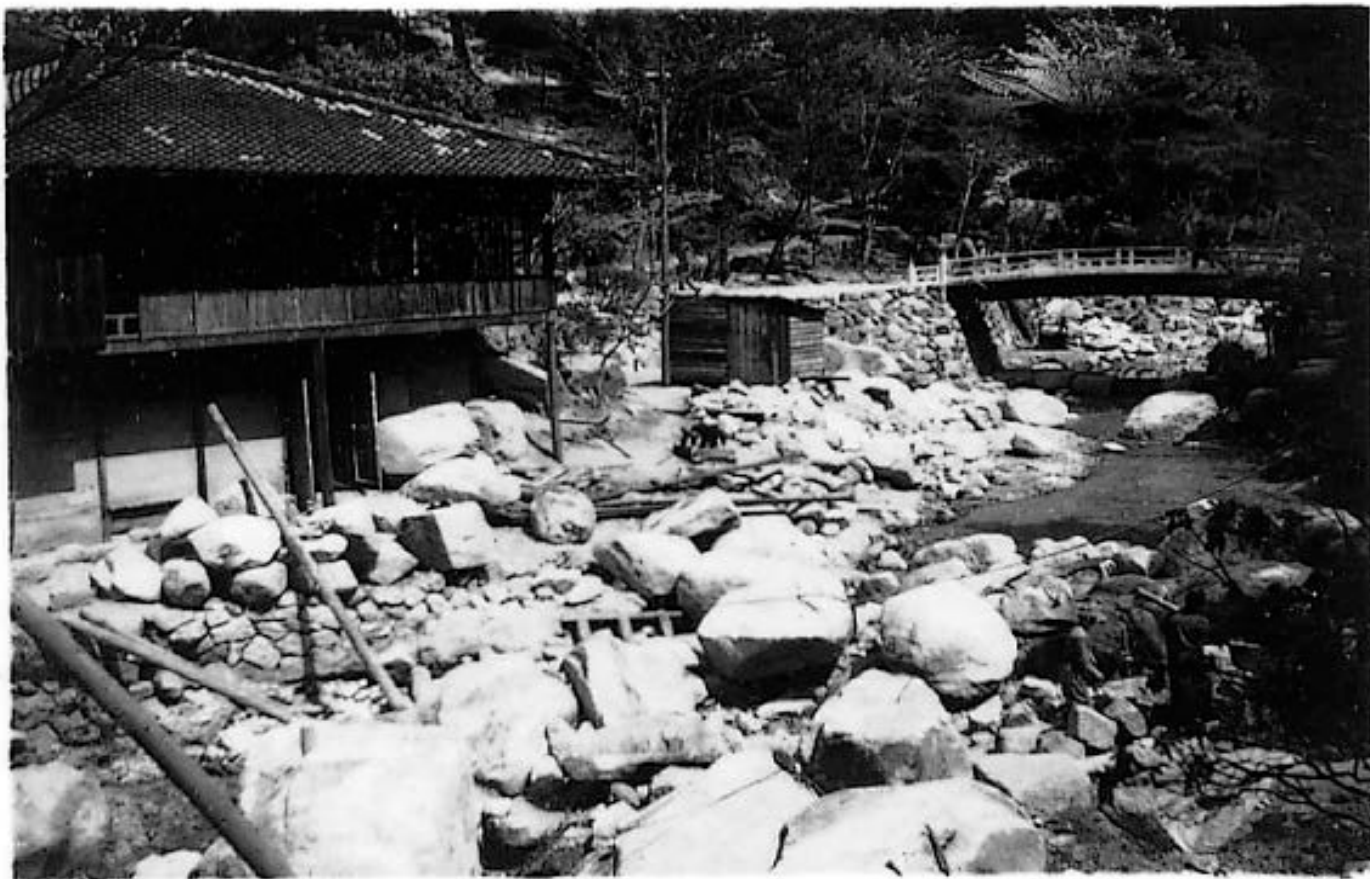
Damage downstream from Momiji Bridge (※1)

The Makurazaki Typhoon made landfall near Makurazaki City, Kagoshima Prefecture, around 14:00 on September 17, 1945.

After making landfall the typhoon moved northeast. As a result, Hiroshima experienced fierce wind with a maximum speed of 30.2m/s, and a total rainfall of 218.7mm, with a maximum hourly rainfall of 57.1mm. Shortly after the end of WWII, there was little weather information and disaster prevention systems were inadequate, causing great damage in various places, especially in Hiroshima Prefecture, where more than 2,000 people were killed or went missing.

On Itsukushima, debris flow disasters occurred at the Momijidani, Shiraito, and Omoto Rivers.

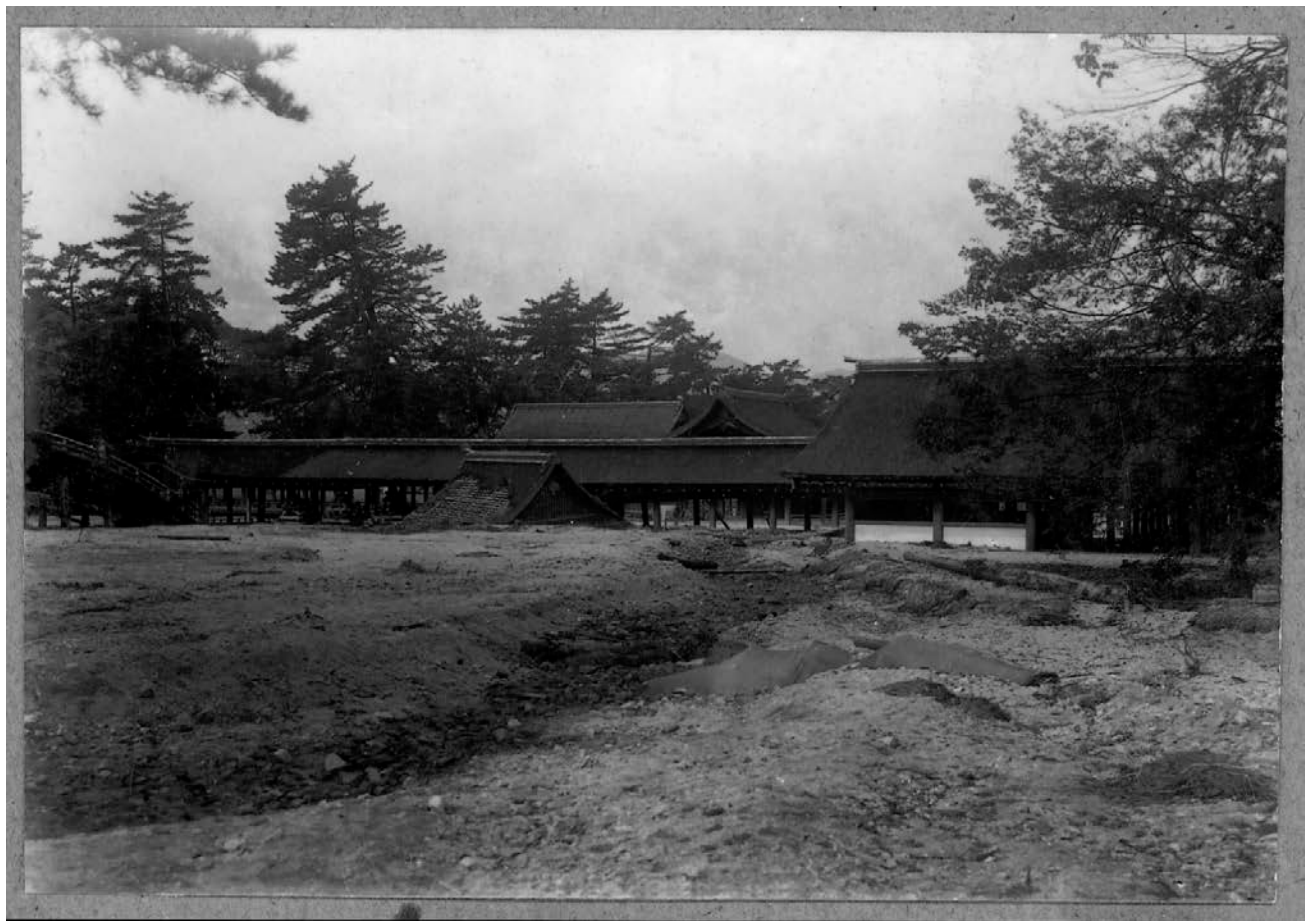
Near Sorihashi Bridge, Tenjin Shrine, and Oguni Shrine [September 1945] (※1)

Itsukushima Shrine was covered by sediment and driftwood

The area around the Momijidani River was registered as a designated sediment control area on March 13, 1934. After that sediment control dams were built, but they were insufficient to stop the debris flow generated by the Makurazaki Typhoon. Huge stones and driftwood flushed through the middle and lower stream and reached grounds of Itsukushima Shrine. During the disaster rehabilitation project, 16,000m<sup>3</sup> had to be dredged.

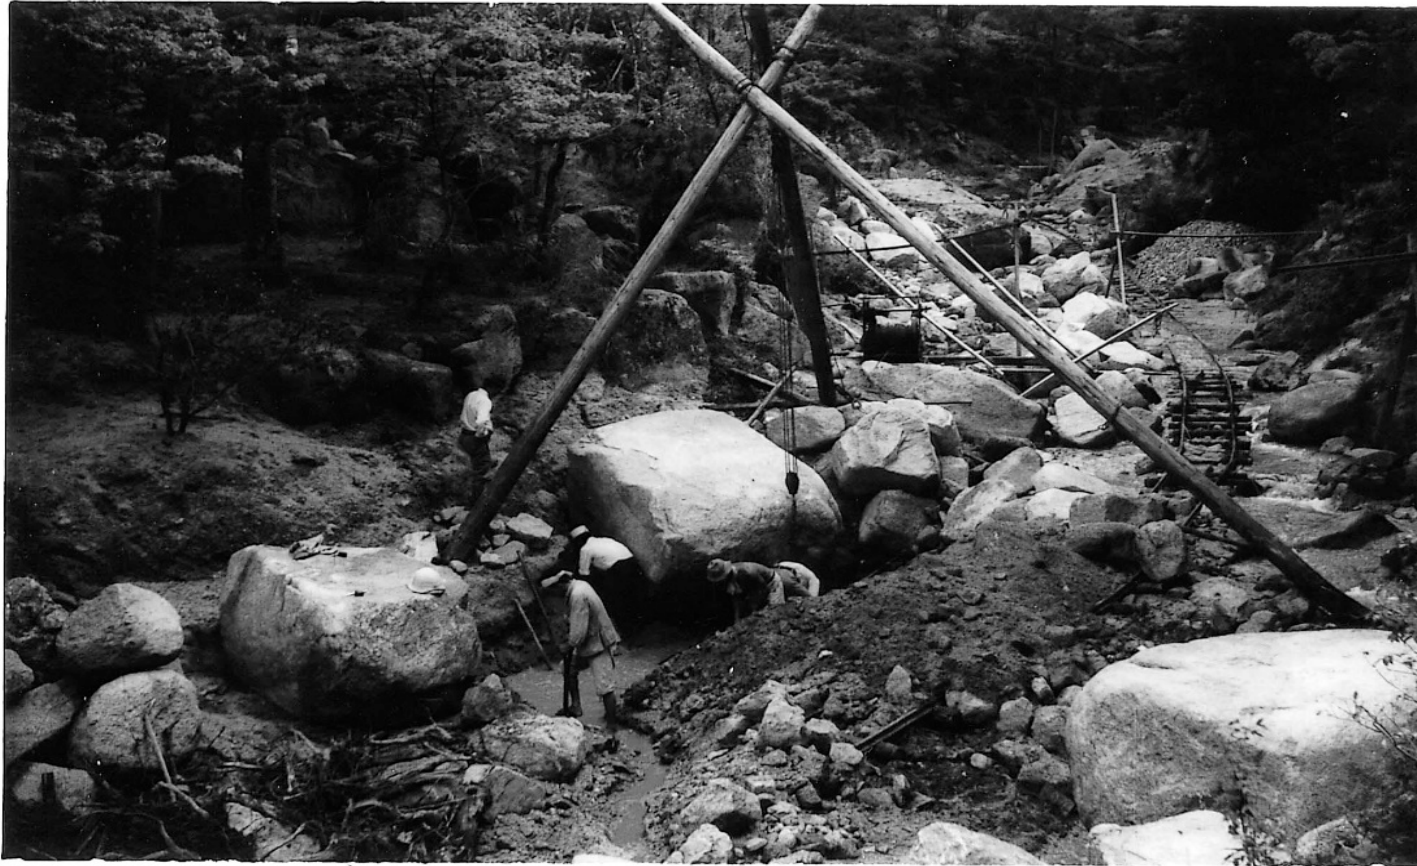
Construction status of the channel works upstream from Momiji Bridge (※1)

### Carrying stones using the "kagurasan (wooden tripod)" method

The method called "kagurasan", wooden tripod with a chain block, was used to move the boulders. The gardeners move the already present megaliths and gravel, without prior processing, a stone stealer, or mallet.

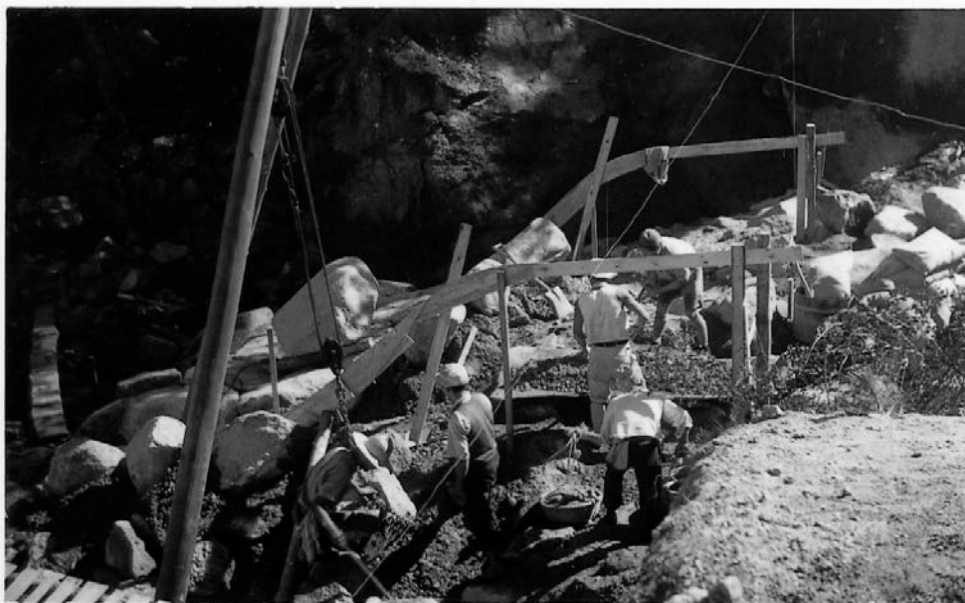
Construction status of the No.5 dam in 1949 (※1)

### Construction of sediment control dam using concrete (under the stones)

Wooden rulers as the marks were placed, concrete was mixed at the field to construct dam, and the dam surface was covered with local quarry stone. So that concrete is not exposed.

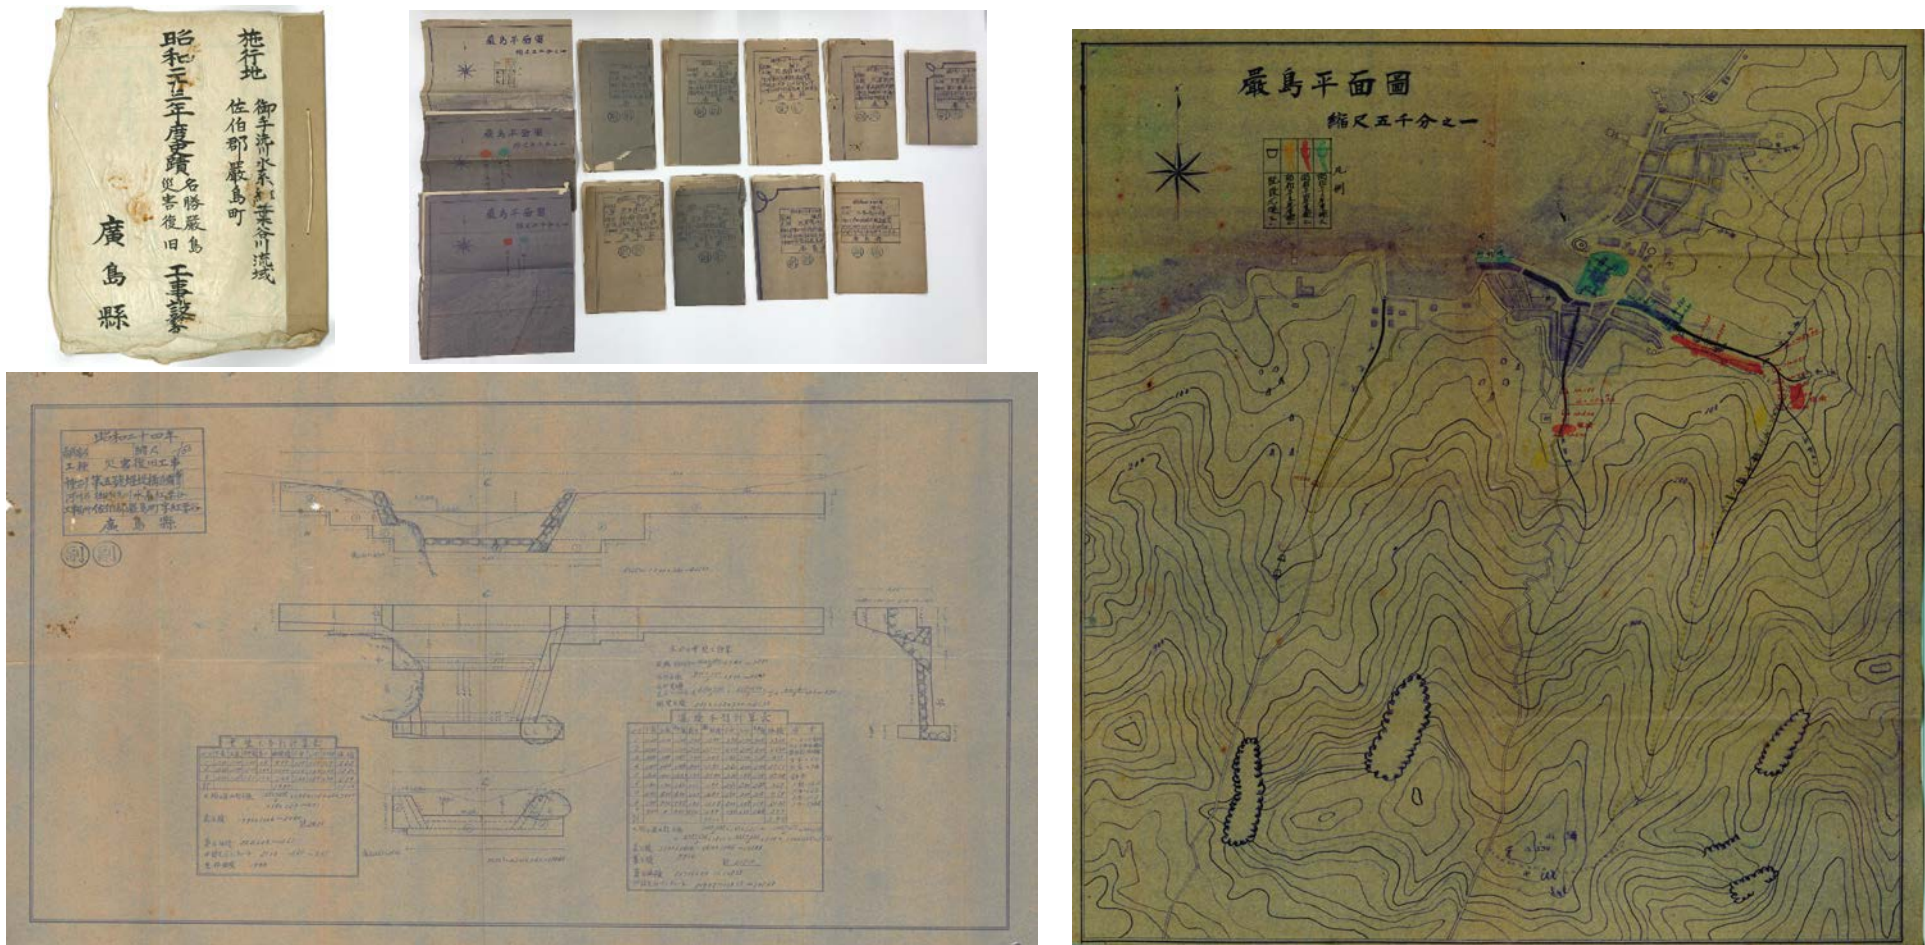
Part of the attachment (※3)

The dimensions of the sediment control dams are confirmed in the "Design of Disaster Rehabilitation Project at the historic site and place of scenic beauty of Itsukushima (Hiroshima Pref, 1949) and the attached figures".
